Manhole Inspection Summary

Manhole # S29K__003MH

Location Address: **701 Washington Blvd**

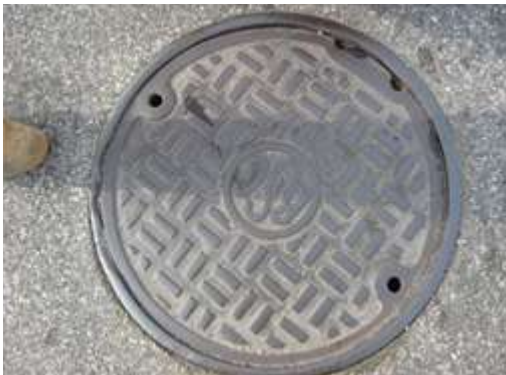
misc-2

cover pic

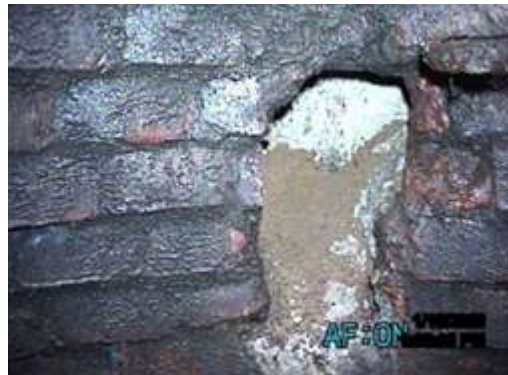
misc-1

closed off connection @ 4 oclk

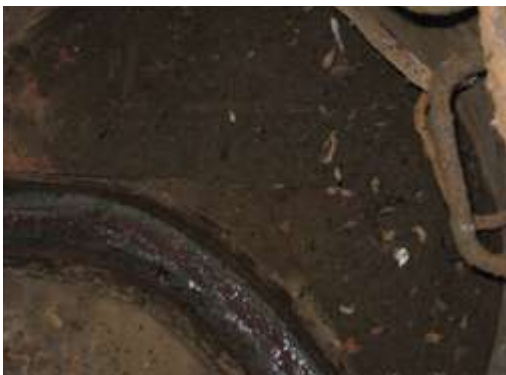
Defect 5

Condition: ☐ Sound ☐ Cracked ☐ Root Intrusion ☐ Deteriorated ☐ Leaks ☒ **Debris**

debris on bench

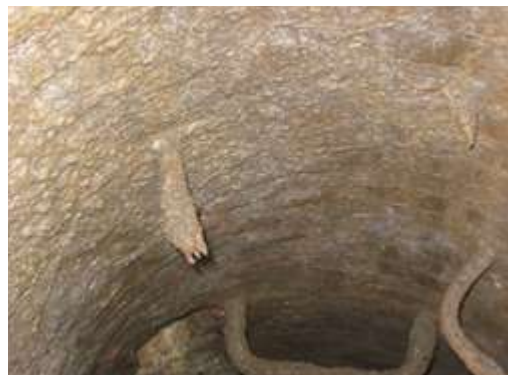
Defect 4

Count: **7** Missing: **1** ☒ **Corroded**

corroded steps, missing rung

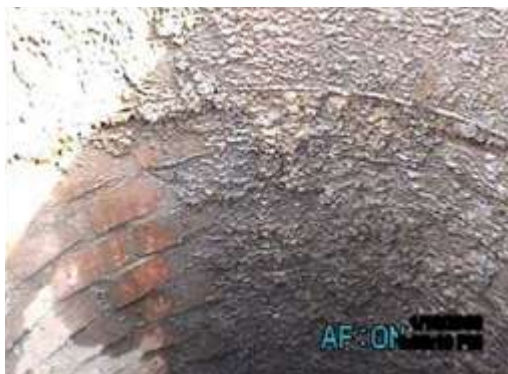
Defect 3

Condition: ☐ Sound ☐ Cracked ☒ **Leaks**

frame leaks

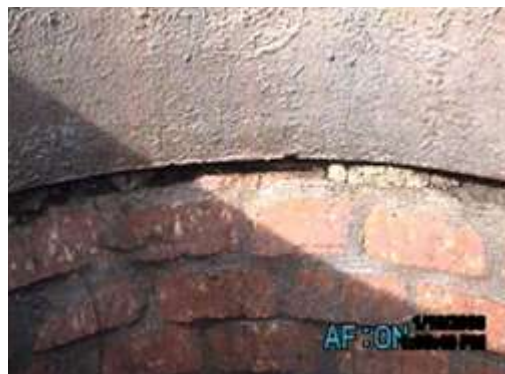
Defect 2

Infiltration: ☐ None ☒ **Joint** ☐ Cracks ☐ Mortar ☐ Roots ☐ Wall

chimney shows infiltration at joint

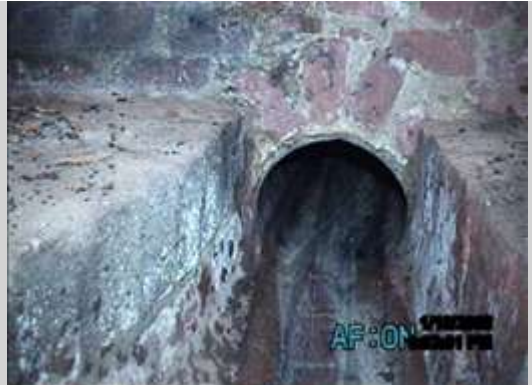
12 O'Clock Outflow

8 in. Circular Gravity Sewer
Pipe Out @ 12 O'Clock

Pipe Height: **8.4** (in.) Rod and Bar (Angled)
Pipe Material: **Clay** ☐ Pipe Lined
Invert Depth: **10.76** (ft.) Flow Characteristics: **None**
Deposits: ☒ None ☐ Mud ☐ Sludge ☐ Debris ☐ Grease
Silt Depth: **0** (in.) Deposits Extent:
Infiltration: **None** Pipe Seal Cond: **Sound**

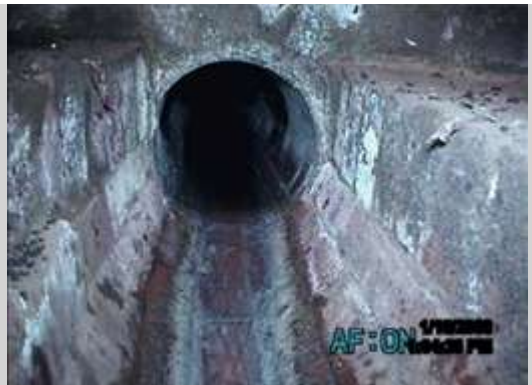
8 O'Clock Inflow

8 in. Circular Gravity Sewer
Pipe In @ 8 O'Clock

Pipe Height: **8.4** (in.) Rod and Bar (Angled)
Pipe Material: **Clay** ☐ Pipe Lined
Invert Depth: **10.10** (ft.) Flow Characteristics: **None**
Deposits: ☒ None ☐ Mud ☐ Sludge ☐ Debris ☐ Grease
Silt Depth: **0** (in.) Deposits Extent:
Infiltration: **None** Pipe Seal Cond: **Sound**
